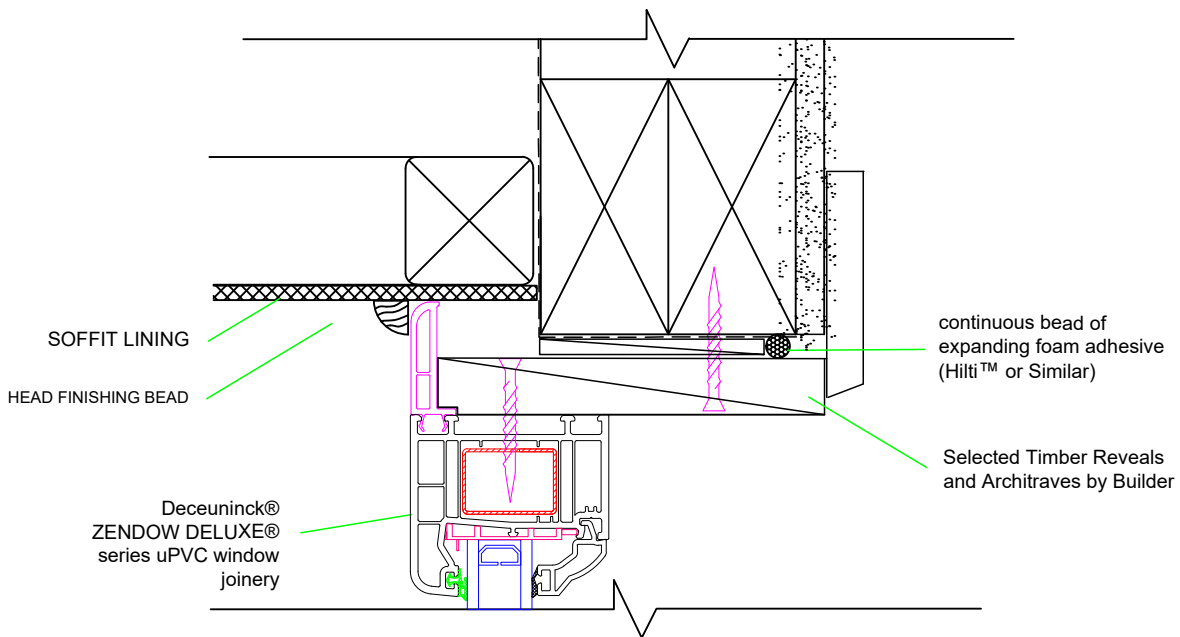
Detail DIR.WIN.A.1.H1

Window Head Detail

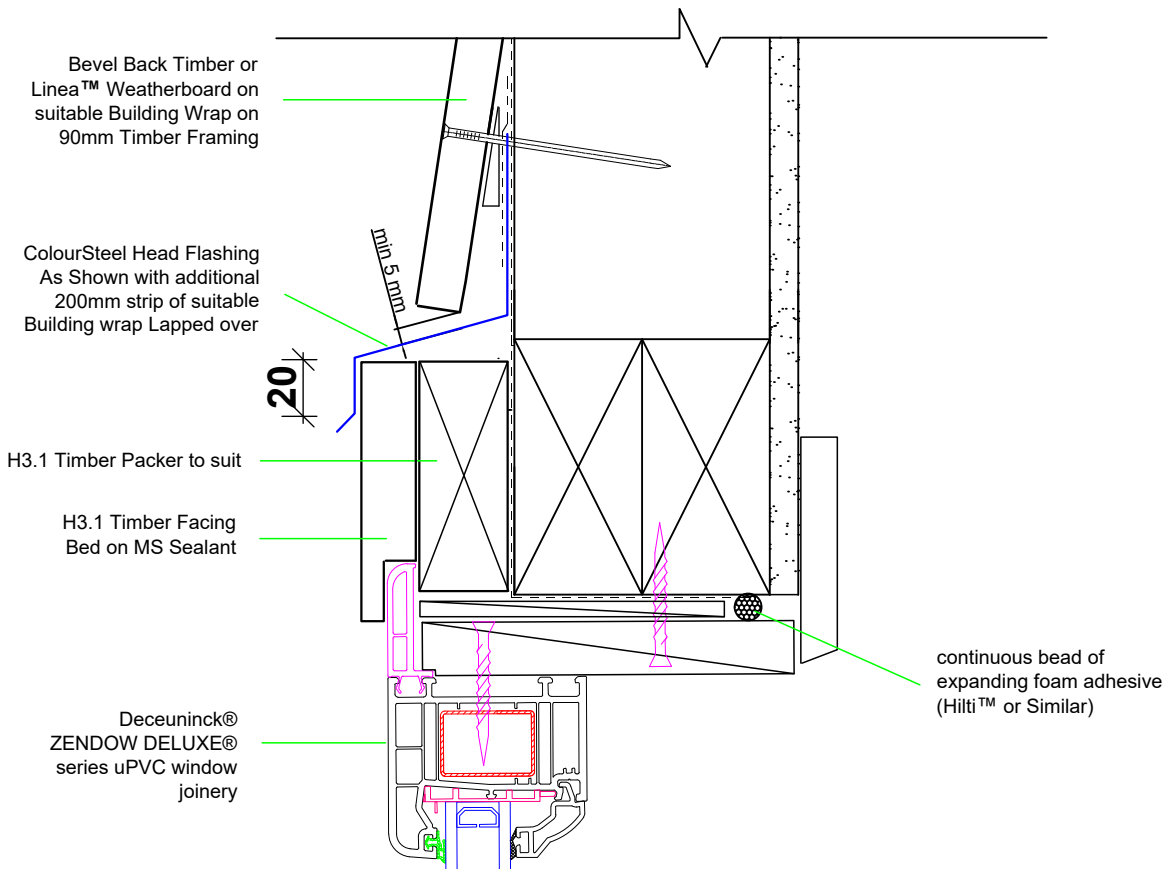
Detail DIR.WIN.A.3.H

Window Head Detail

Bevel back weather
boards direct fix
with timber facings

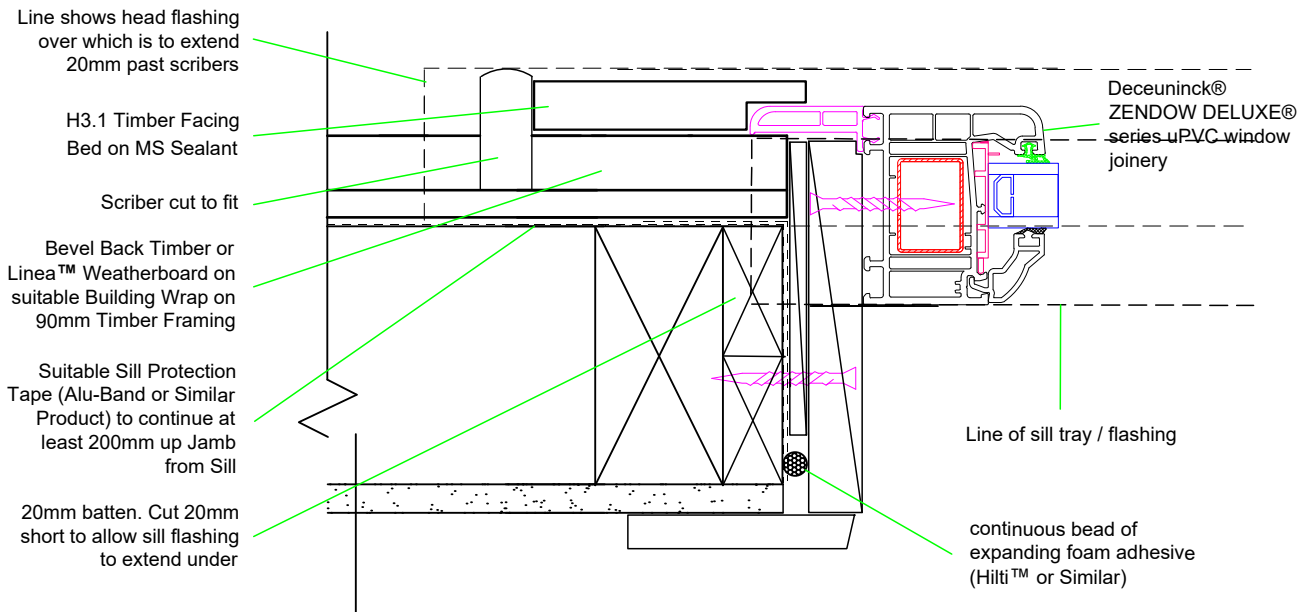
Detail DIR.WIN.A.3.J

Window Jamb Detail

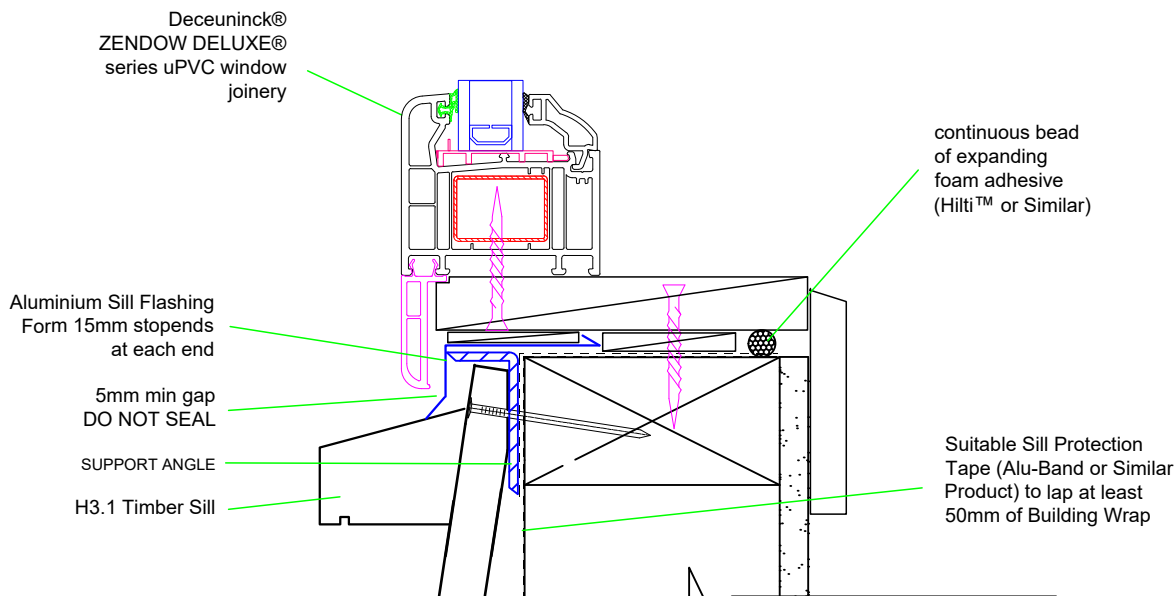
Detail DIR.WIN.A.3.S

Window Sill Detail

Bevel back weather boards direct fix with timber facings
