WINDOW

Bevel back weather boards direct fix with timber facings

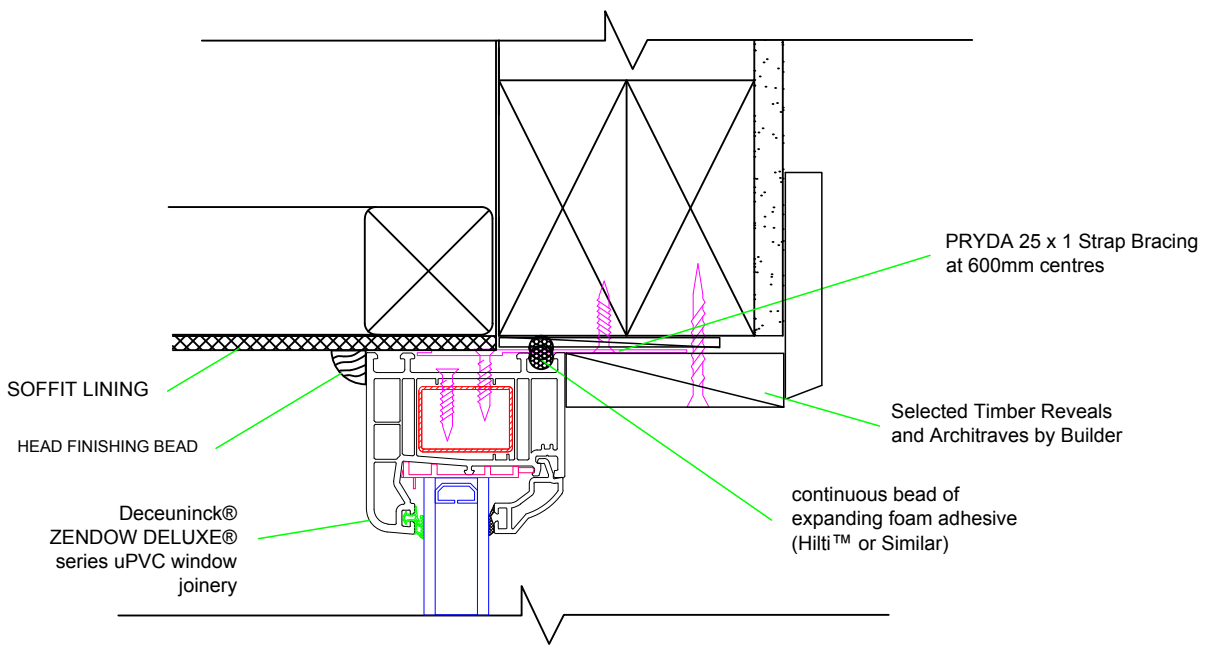
Detail DIR.WIN.A.1.H1

Window Head Detail

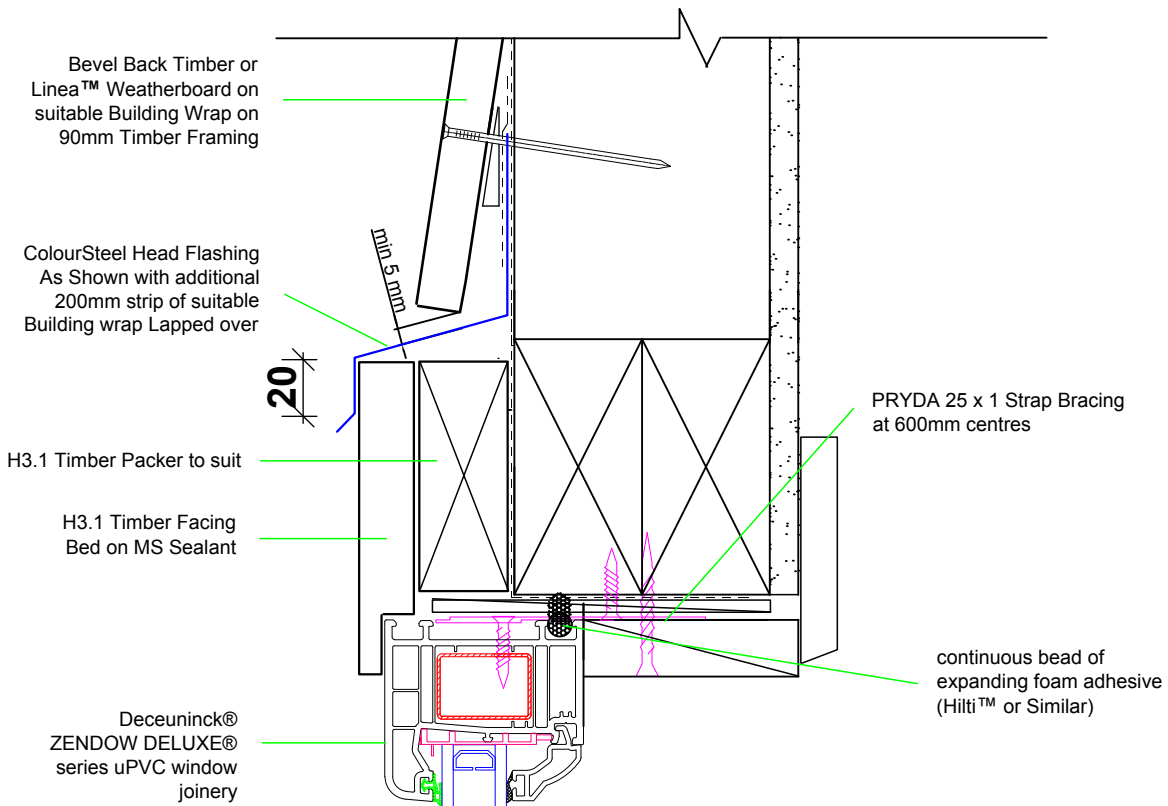
Detail DIR.WIN.A.3.H

Window Head Detail

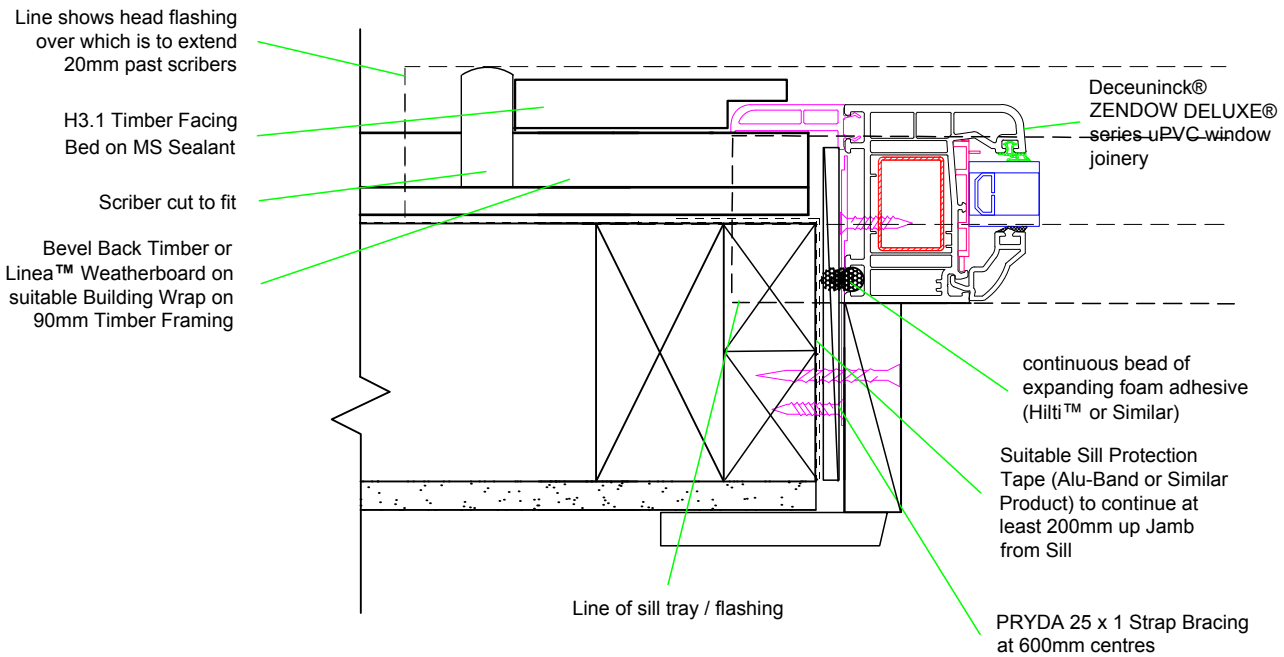
Detail DIR.WIN.A.3.J

Window Jamb Detail

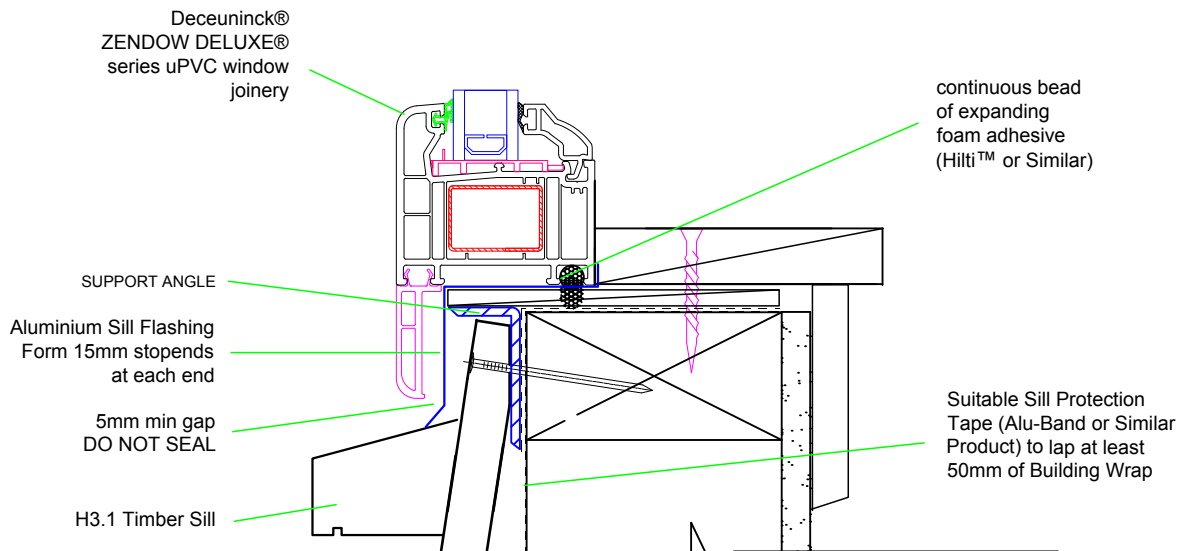
Detail DIR.WIN.A.3.S

Window Sill Detail

Bevel back weather boards direct fix with timber facings
